# REDUCING 'FAILED TO DETECT' CRASHES AT RURAL CROSSROADS

Document Title: Reducing 'failed to detect' crashes at rural crossroads

Prepared for: AA Research Foundation

Prepared by: Mackie Research

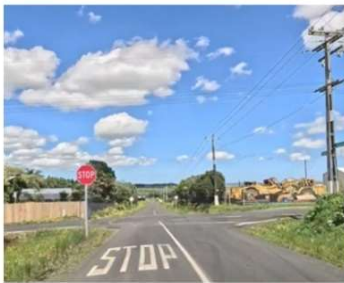
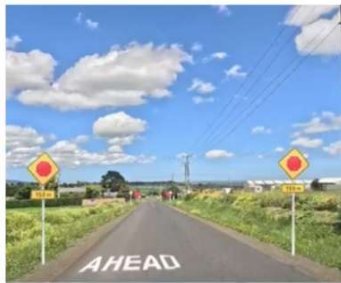
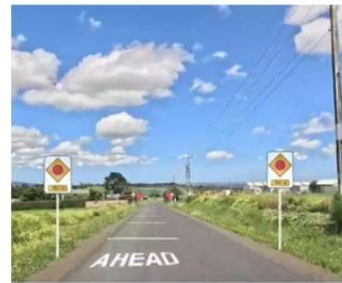
Following this, a trial of practical and cost-effective ‘failure to detect’ mitigations, predominantly using existing Traffic Control Devices (TCDs), was undertaken with 60 participants using virtual simulation technology.

Baseline

Mitigation 1

Mitigation 2

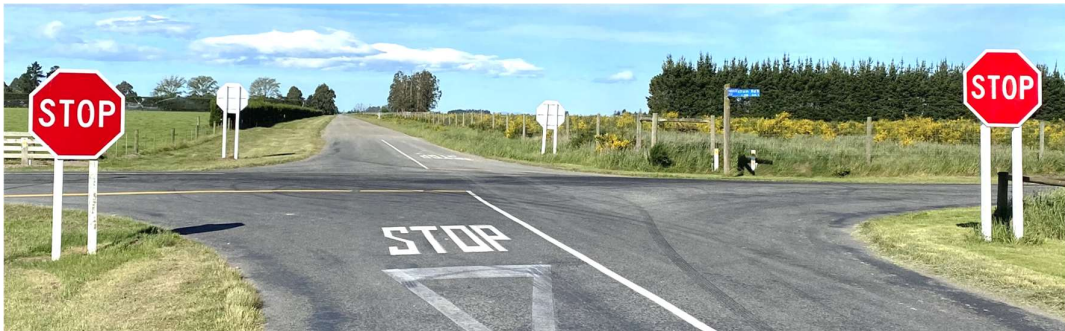
*Figure 1: Oversize Stop signs at Mitcham Hepburns crossroad, Canterbury NZ.*

Additional controls (e.g. Figure 1 below) are sometimes used at rural crossroads. This suggests that road safety engineers are aware of the issue of motorists not detecting intersections and the need for additional interventions. Further evidence of the extent and nature of ‘failed to detect rural intersection crashes, along with evidence of the effectiveness of low-cost treatments, would give confidence to a nationwide treatment strategy that would yield tangible safety benefits.

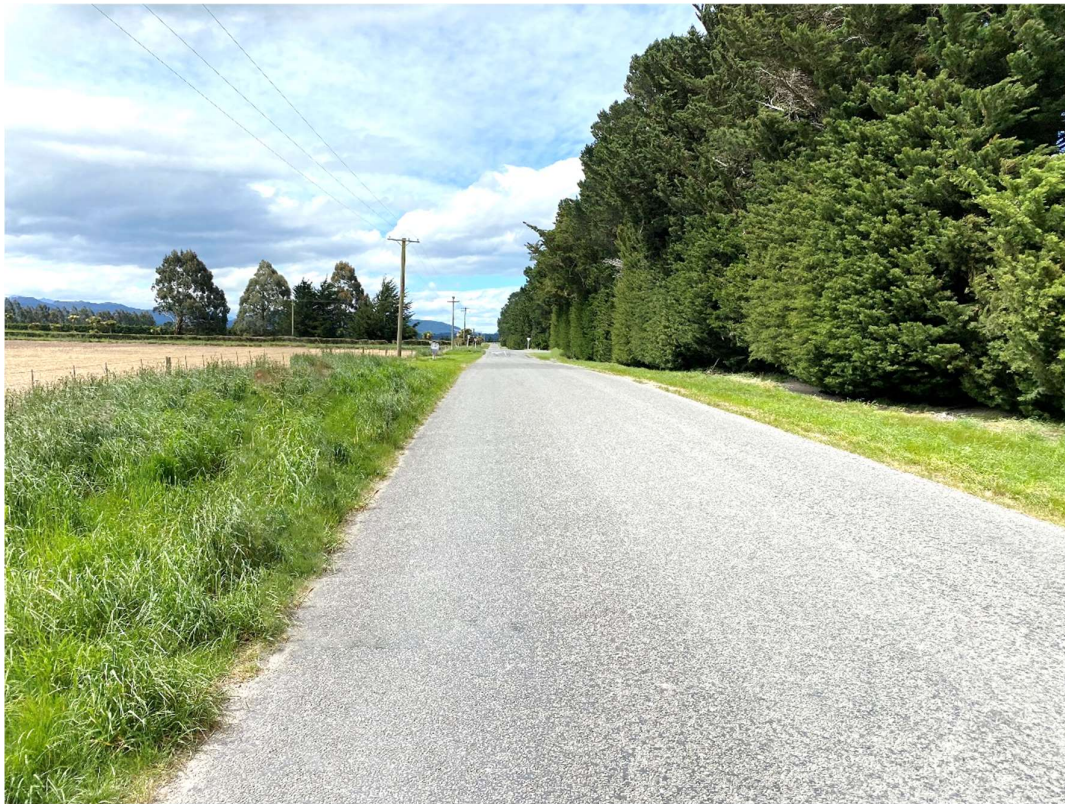
*Figure 2: Typical features of an approach to a rural crossroad in New Zealand*

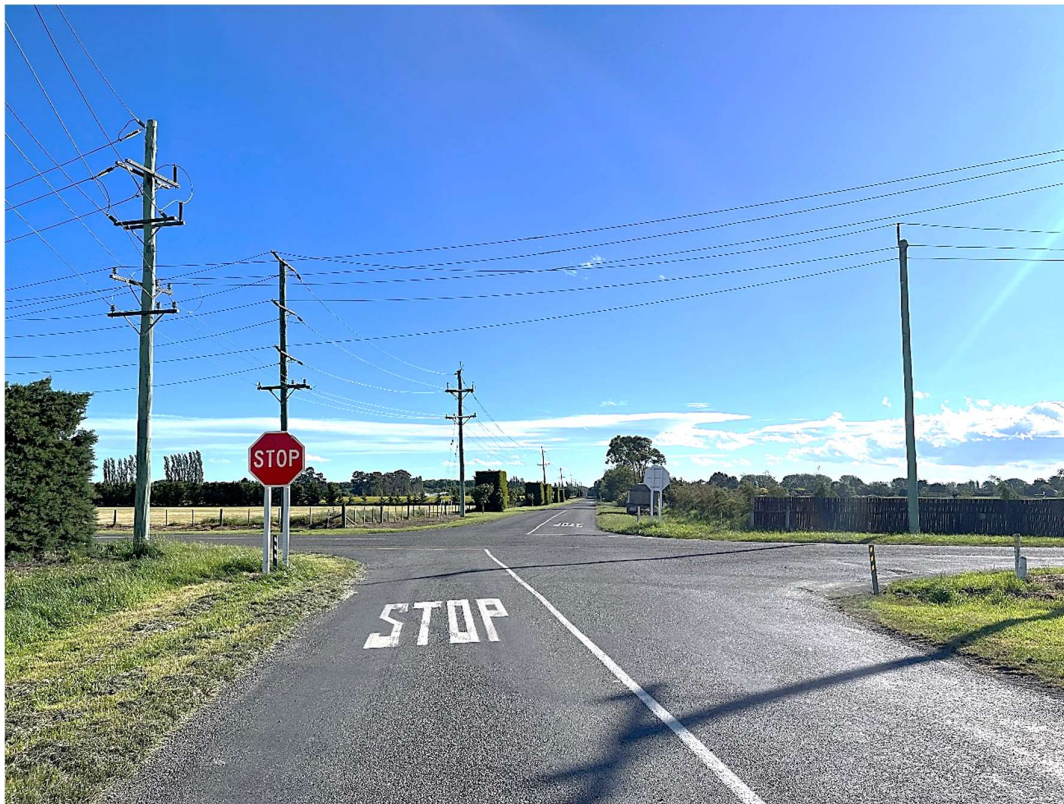
*Figure 3: Rural crossroad in New Zealand with oversize Stop signs.*

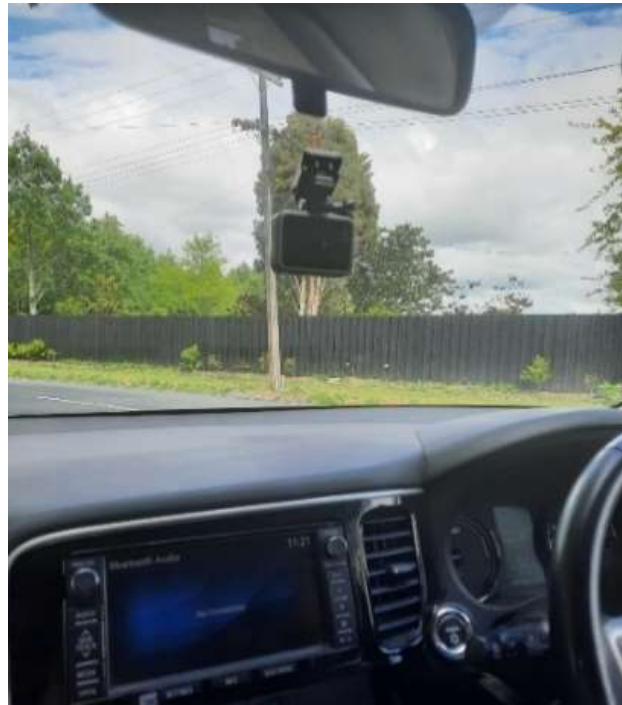
*Figure 4: Video camera positioning.*

Filming took place during daylight hours and in good weather. At each crossroad site, a route of approximately 5 minutes was filmed, with at least 3 minutes of driving prior to arriving at the crossroad. The filming vehicle travelled at a target speed of approximately 80km/h. This was based on testing prior to filming where the team found that this speed provided the most 'realistic' impression of general rural travel speeds when presented on screen.

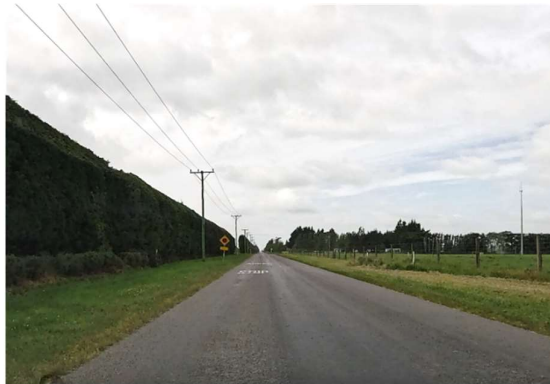
Intersection of Dromore Methven Road (yielding) and Mitcham Road.

- Flat geography
- Priority road difficult to see
- Visual continuity (long hedge)
- Long straight prior to crossroad

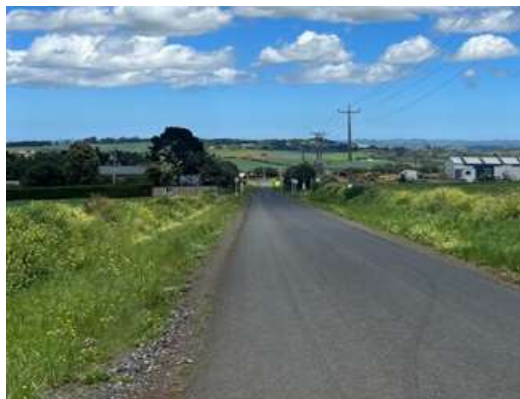
Auckland District: **Downhill Approach Crossroad**  
Intersection of Middleton Road (yielding) and Attwell Road.

- Moderate downhill slope
- Priority road difficult to see
- Sense of visual continuity
- Middleton Road had priority at prior intersections

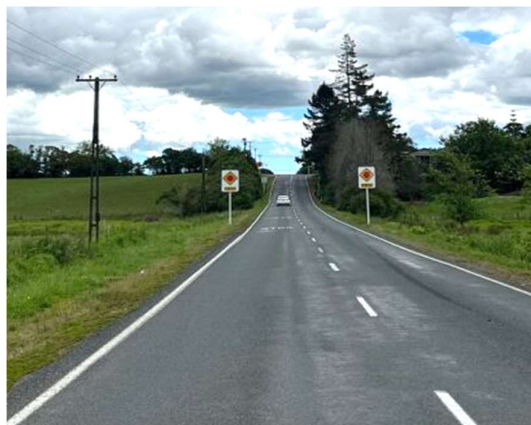
Auckland District: **Uphill Approach Crossroad**  
Intersection of Tourist Road (yielding) and Monument Road.

- Moderate uphill slope
- Priority road difficult to see
- Considerable vegetation on approach to crossroad

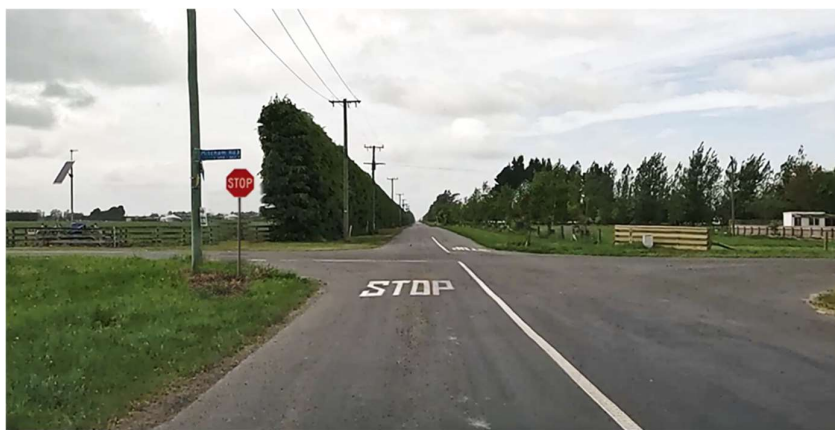
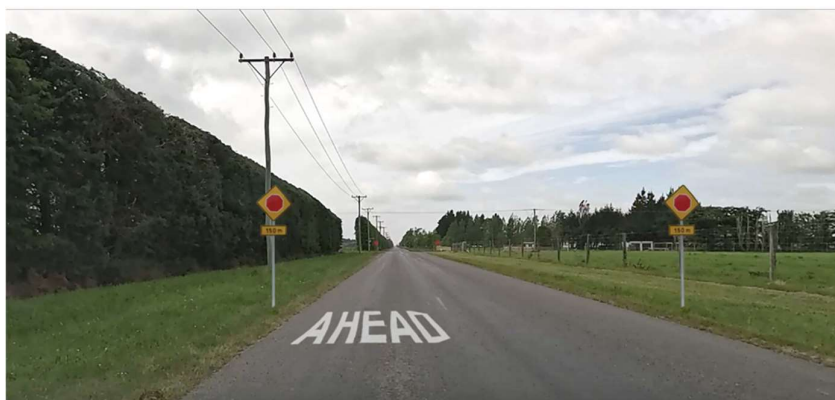
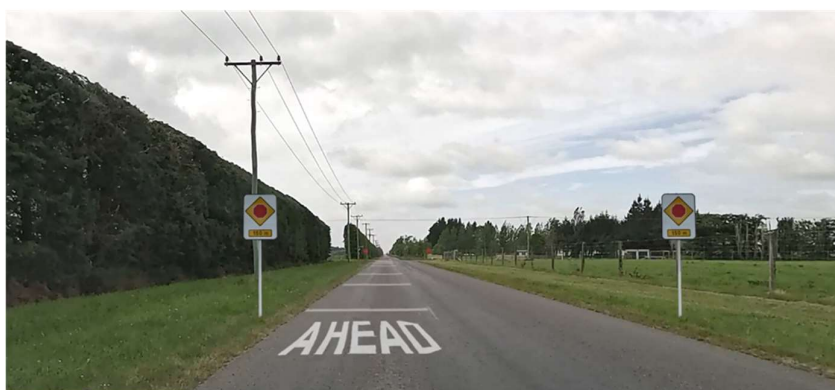
Figure 6: Example of video augmentation and mitigations at crossroads site.

Figure 5 details each mitigation condition, Figure 6 shows an example of mitigations created through video augmentation at one site. For standard treatments, additional signage and markings were digitally removed from the video to achieve the specifications in Figure 5. However, centreline markings were retained as they were videoed onsite because, depending on the nature of the road, approaches to crossroads may, or may not, have centrelines present. The team wished to have both options included in the trial.

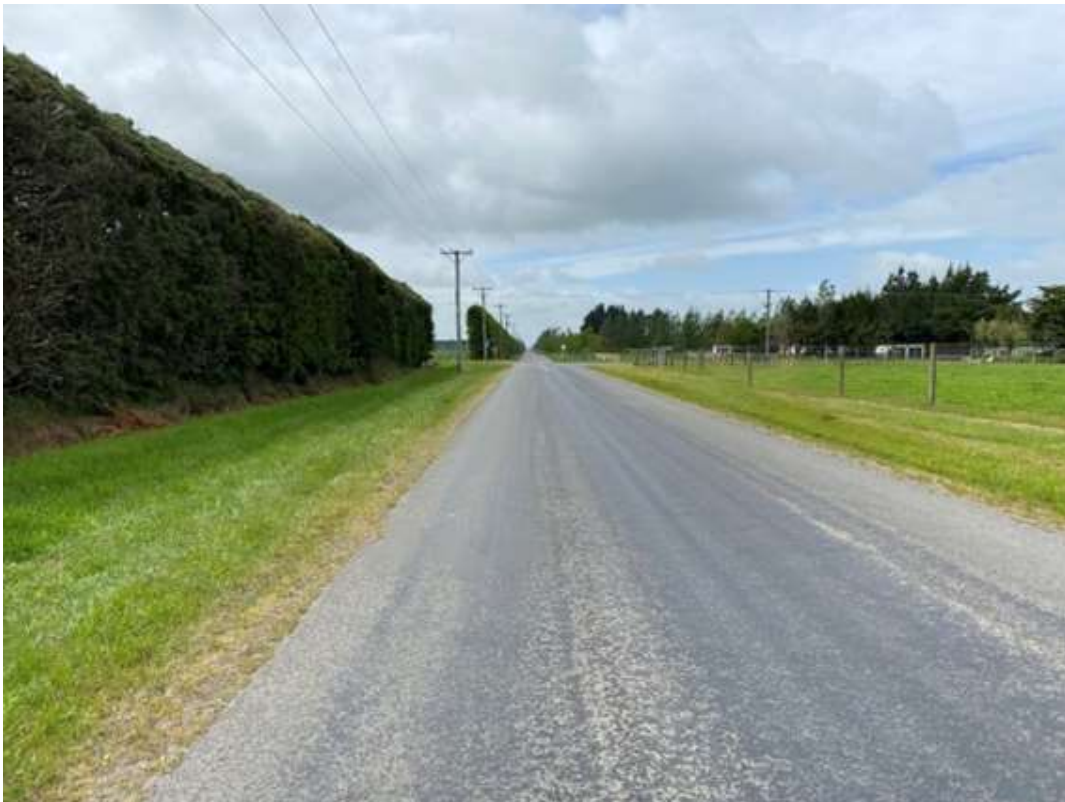
Figure 11: Example of continuity cues (hedge) at a site in Canterbury

The road environment at the crossroad itself is also a potential factor in ‘failure to detect’ crashes, for example, if the priority road is difficult to see, or the road appears visually to continue on straight ahead.

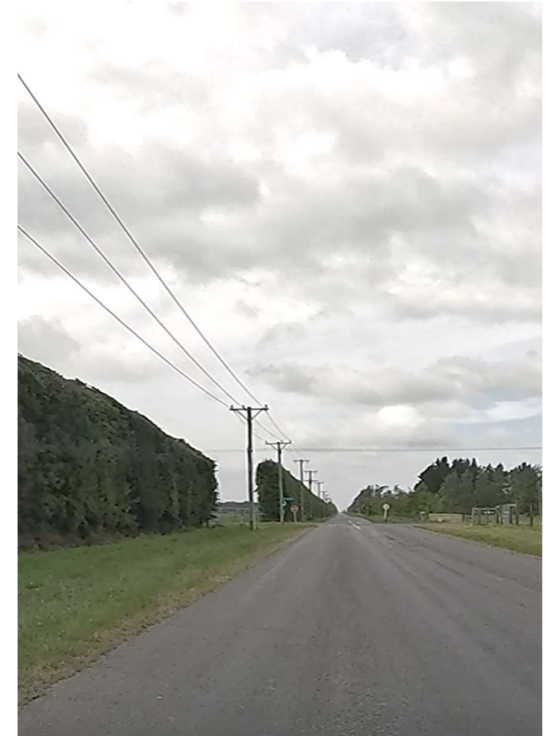
*Figure 13: Photograph of crossroad as it currently appears in real life.*

This site has many of the characteristics of sites where ‘failure to detect’ crossroad crashes were identified during the crash data analysis. The yielding approach is flat and straight for a long distance, the priority road is buried in the landscape and obscured by a hedgerow making it difficult to detect. This hedgerow also provides visual continuity cues suggesting the yielding road continues without interruption, and minimal road signage at the crossroad is difficult to see against the green treed background (Figure 13).

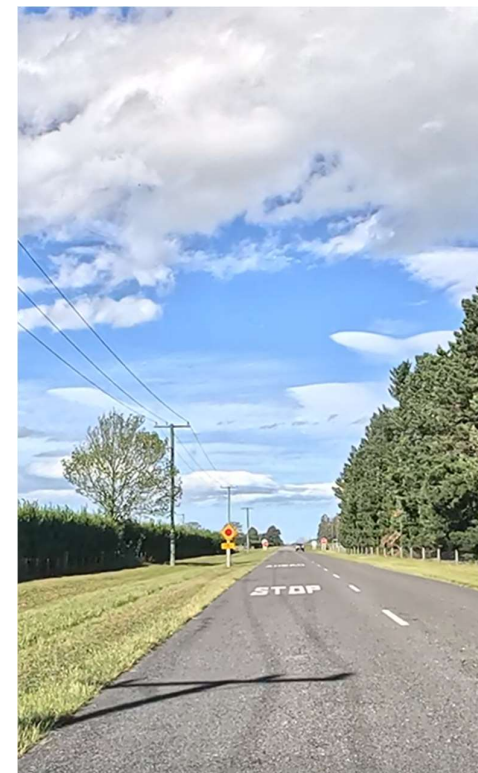
Figure 15: Photograph of the crossroad as it currently appears in real life.

This site, a straight flat road in Ashburton (Figure 15), was the site of a serious ‘failed to detect’ crash in 2019. At the time, the site only had a Give Way sign at the crossroad with no warning signs. The site has many of the characteristics of sites where ‘failure to detect’ crossroad crashes were identified during the crash data analysis. It is flat and straight, with a strong sense of the yielding road continuing through the crossroad without interruption. The priority road is partially obscured in the landscape due to a hedgerow on the right and because the geography is very flat. The road signage is somewhat difficult to see against the background.

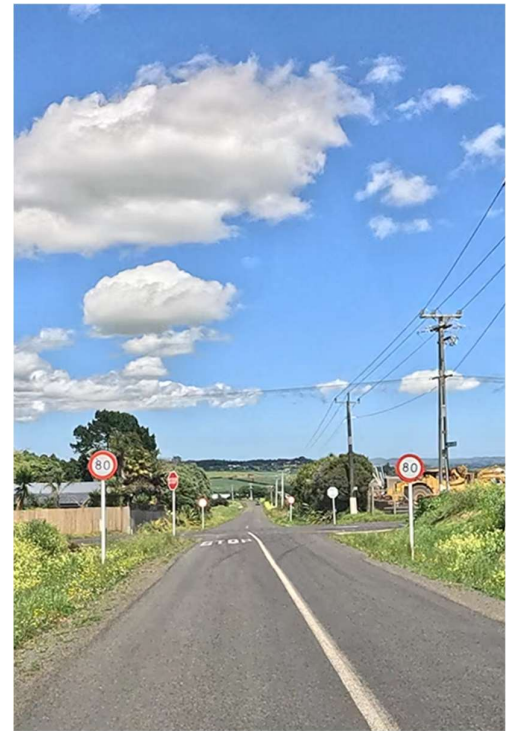
Figure 17: Photograph of the crossroad as it currently appears in real life.

This Auckland site with its steady downhill slope to the crossroad is less typical of sites where ‘failure to detect’ crashes have occurred. However, it does have some of the typical features: the road is straight, has a sense of continuity beyond the crossroad, and the priority road is difficult to see as it is buried in the landscape due to banks and hedgerows. Additionally, this site has some signage typical of crossroads, such as speed limit signs which only reinforce continuity (see Figure 17). The yielding road also had priority at previous intersections. Interestingly, in 2018, a ‘failure to detect’ crash occurred at this site. At the time, there was a single Stop sign at the crossroad and no warning signs.

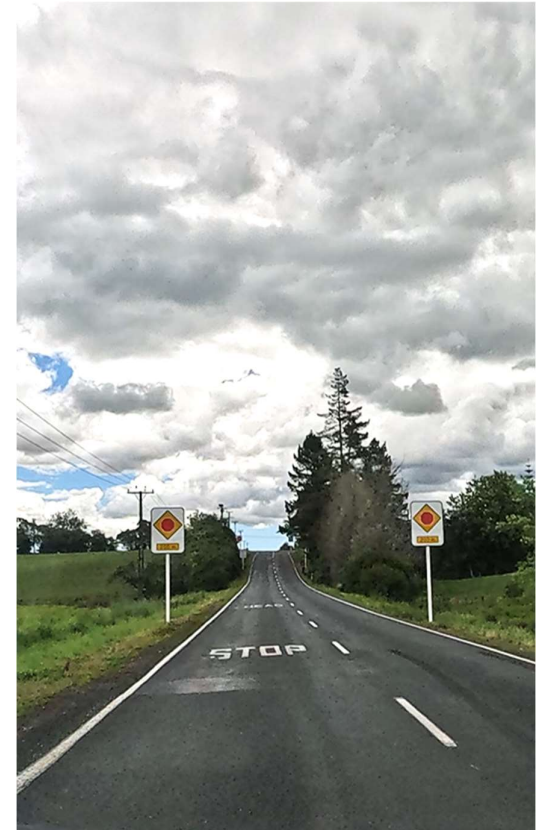
Figure 19: Photograph of the crossroad as it currently appears in real life.

This Auckland site has a steady uphill slope with the crossroad being positioned on the brow of the hill and invisible from the yielding road. The crossroad was less typical of sites where ‘failure to detect’ crashes have occurred, in that the yielding road didn’t appear to continue beyond the crossroad because it disappeared over the hill brow. Interestingly, at the time of filming, interventions had been placed at this site to increase the conspicuity of the crossroad (see Figure 19), suggesting that the site has already been considered risky. The additional signs and markings were digitally removed before adding the trial mitigation conditions.

1. Warning signage was set against the rise leading up to the crossroad which meant they were viewed against a heavy tree line.
2. The tree line along the top of the ridge has gaps with light shining through that may have attracted attention away from the warning signage.
3. The right-side oversize stop signs (included in both mitigations) was obscured by trees from the view of the yielding driver. These signs may be a key part of the mitigation. It is possible that the lack of visibility of this component of the mitigation resulted in participants being unsure of the intent of the warning sign until they were much closer than at the other sites.
